SYSTEM FAILURE CASE STUDIES

JANUARY 2011 VOLUME 5 ISSUE 1

Fire in the Sky

Trans World Airlines (TWA) flight 800 was only twelve minutes into a July 19, 1996 trip from New York to Paris when an in-flight explosion destroyed the passenger jet, plunging it into the Atlantic with 230 people on board. The aircraft was climbing south of the Long Island coast near East Moriches, New York when suddenly, portions of the Boeing 747-131 fuselage beneath the center wing fuel tank began to separate from the rest of the aircraft. This led to the loss of the entire forward fuselage. Investigators labored over 15 months to recover more than 300 tons of debris and to separate material of the Boeing from earlier boat and aircraft accidents; the subsequent National Transportation Safety Board (NTSB) investigation required over four years. Eventually, NTSB concluded that an explosion in the center wing fuel tank separated the fuselage (Figure 1), causing the passenger jet to crash into the ocean.

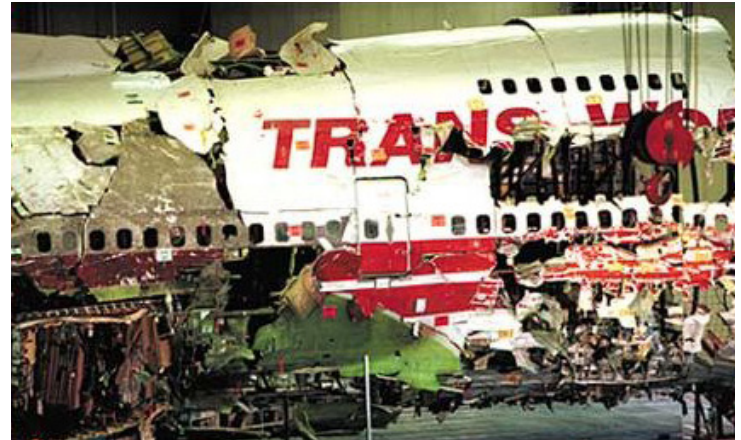
Figure 1: The reconstructed fuselage of TWA 800

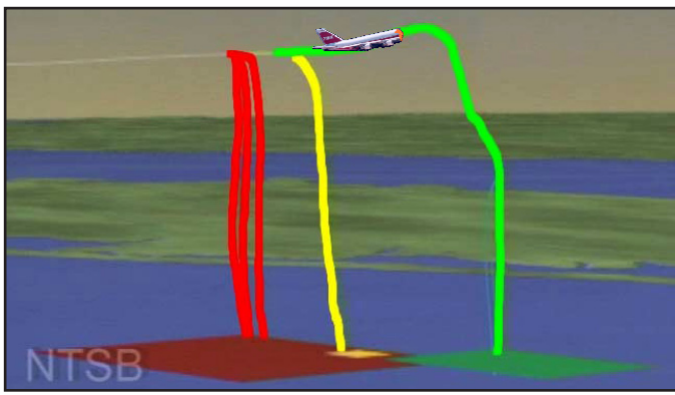
Following a fruitless search for survivors, a ten-month recovery effort by multiple agencies and companies found three debris fields, called red, yellow, and green (Figure 2). Within the first weeks, investigators found initial evidence of an explosive event in a fuel tank. Aircraft, fire, and explosive experts from the NTSB, DoD, FBI, ATF, FAA, and other parties associated with the investigation examined each recovered piece (over 95% of the aircraft) for evidence of bomb, missile or high-order explosive characteristics. They found no such evidence, and 18 months after the crash, the FBI officially terminated its criminal investigation. The safety investigation continued for nearly three more years.

Figure 2: Red, Yellow, and Green Debris Fields

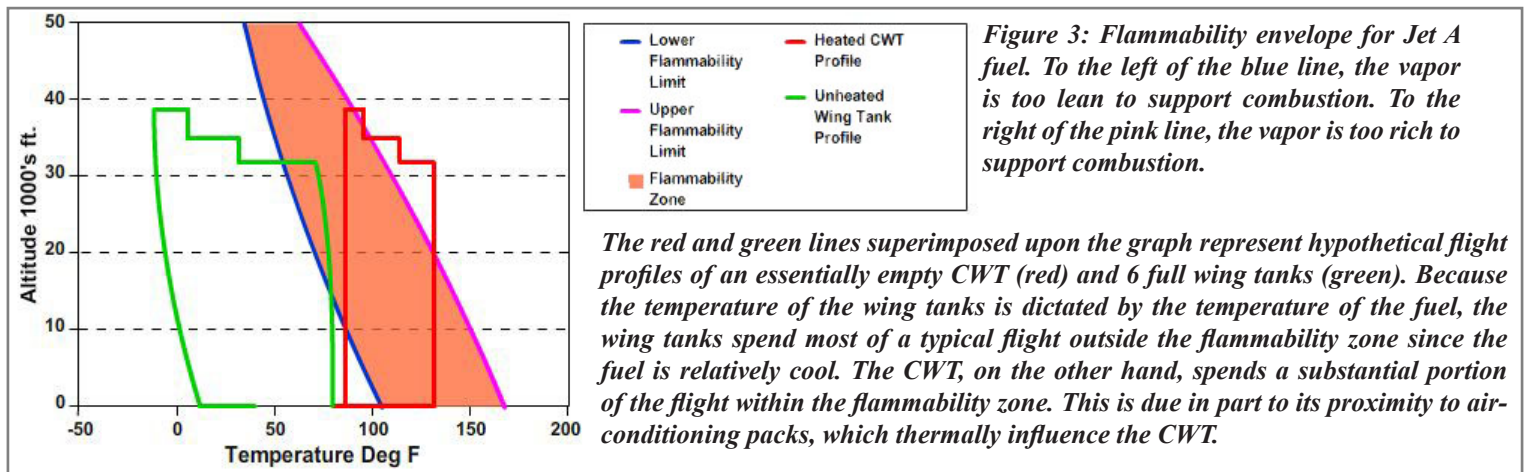
The Boeing 747-100 series uses Jet-A fuel from seven fuel tanks. Each wing contains three tanks. The lower fuselage holds a seventh tank, known as the center wing fuel tank (Figure 4). The CWT has a fuel capacity of 86,363 pounds, but whenever the six wing tanks hold sufficient fuel for a flight, the CWT only contains fuel remaining from the last flight, providing optimal spanwise wing load distribution. Ground crew personnel measured approximately 300 (about 50 gallons) pounds of fuel in the CWT prior to Flight 800's final takeoff. Under such conditions, the CWT ullage – the unfilled portion of the tank above the surface of the fuel – contains a mixture of fuel molecules and air whose combustibility depends upon its fuel-air ratio, temperature, and pressure. The aircraft's three air-conditioning packs, which could radiate heat at up to 350 degrees F, rested in an uninsulated, unvented compartment just inches beneath the CWT's aluminum floor. The tank and ullage absorbed heat from the packs for 2 ½ hours on the ground. Testing found that a near-empty center tank heats quickly, speeding fuel evaporation and increasing the flammability of the ullage. Additionally, increasing altitude as the airplane climbed lowered the air pressure, reducing the temperature needed to ignite the fuel/air mixture. (Figure 3 illustrates the flammability envelope for Jet-A fuel.)

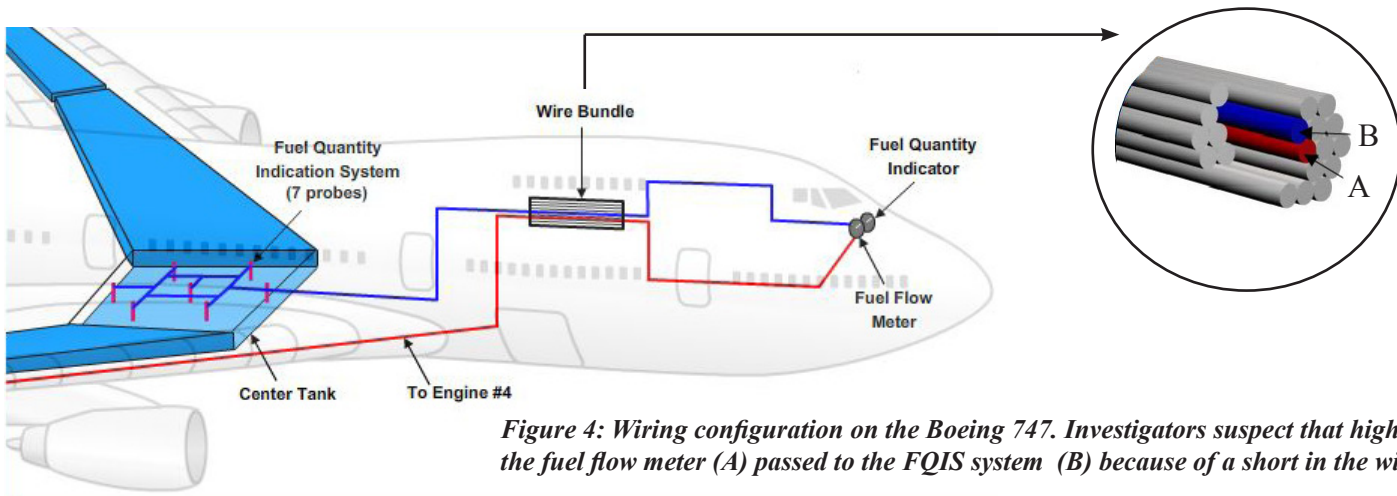
The minimum ignition energy for hydrocarbon fuels is 0.25 millijoules (mJ). To keep the vapor in the tank from igniting, the power supplied to FQIS wiring was intended to have a limit of 0.02 mJ, which would be extremely low when compared to other B-747 systems. The FQIS wiring runs from the fuel tanks to the flight deck along raceways shared with wiring from other systems such as the cockpit voice recorder (CVR), fuel flow meter, and cabin lights. Such circuits carry much higher voltages and energies than allowed in the FQIS. For example, some cabin lights operate at up to 350 VAC at 400 hertz. FQIS wires co-routed with these other wires in large bundles were found tightly bound together, so that a chafe or cut could affect more than one wire (see Figure 4).

Because FQIS wires are the only wires to enter the CWT and because they are co-routed within wire bundles containing circuitry from higher-voltage systems, investigators theorized that a high-voltage circuit contacted FQIS wires due to chafed, frayed, or otherwise damaged conditions. Once this higher voltage passed through FQIS wires to the FQIS probes inside the CWT, a latent fault on the probes, such as silver sulfide deposits, may have caused an electrical arc and subsequent tank explosion.

Figure 4: Wiring configuration on the Boeing 747. Investigators suspect that high voltage from the fuel flow meter (A) passed to the FQIS system (B) because of a short in the wire bundle.

wire. The same wire routes were then found to contain other potential electrical energy sources, such as the cabin lights that had been beneath the cockpit. The cabin lights had required maintenance on multiple occasions in the month before the accident. Any of these potential sources could have passed excessive energy to the FQIS system within the CWT (See Figure 4).

ers, such as those used on TWA 800, do not function fast enough to reliably prevent excessive energy from entering FQIS wires, as previously assumed. Later, NTSB recommended installing arc-fault circuit breakers and other current limiting devices, instead of simple thermal-mechanical circuit breakers to prevent energy transfers.
